26 March 1992

This letter is the final technical report for Grant No. N00014-90-J-4134 which expired 27 September 1991. This grant was entitled the "Development of a 600 Meter Chirp Sonar." The chirp sonar is a digital FM reflection profiler that generates high signal to noise, quantitative data useful for imaging the seabed and estimating sediment properties. The objective of this project is to develop a chirp sonar for the Naval Oceanographic Office which will conduct subbottom surveys providing acoustic reflection data in conjunction with coring surveys that provide physical property data. The data sets will be used to develop and verify sediment classification models. After the models are developed, they can be used to generate world wide maps of sediment properties from chirp sonar data.

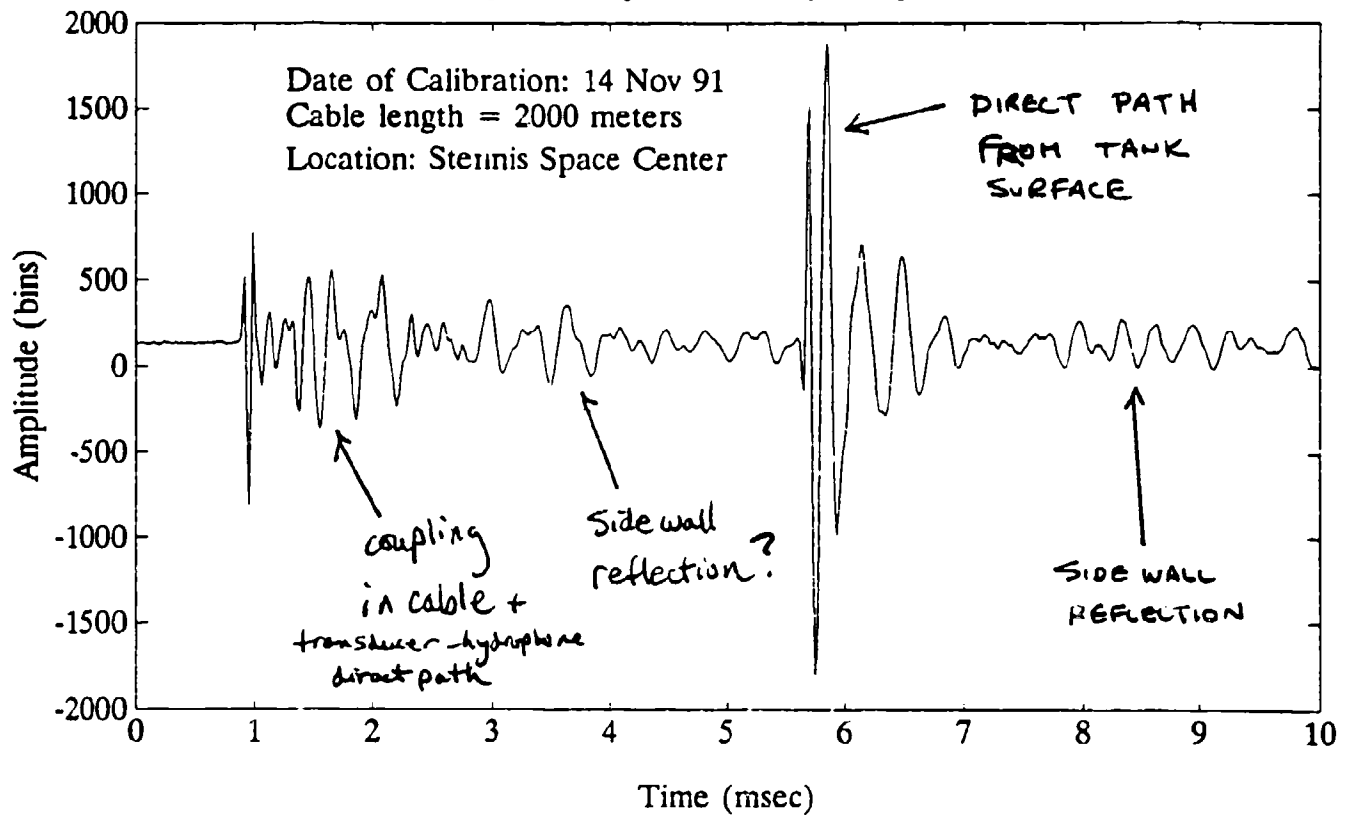
The system response was analyzed at Florida Atlantic University. Figure 1 is the impulse response of the sonar and the 200 meter cable generated by exciting the transmitter with the impulse in Figure 2. As seen in Figure 1, the response measurement was very noisy. It was difficult to obtain a clean response pulse because of pulse elongation generated by the cable, coupling between the transmitted and received pulse in the cable, sound reverberating within the vehicle and reflections off the side of the tank.

Impulse Response of Navy Chirp Sonar

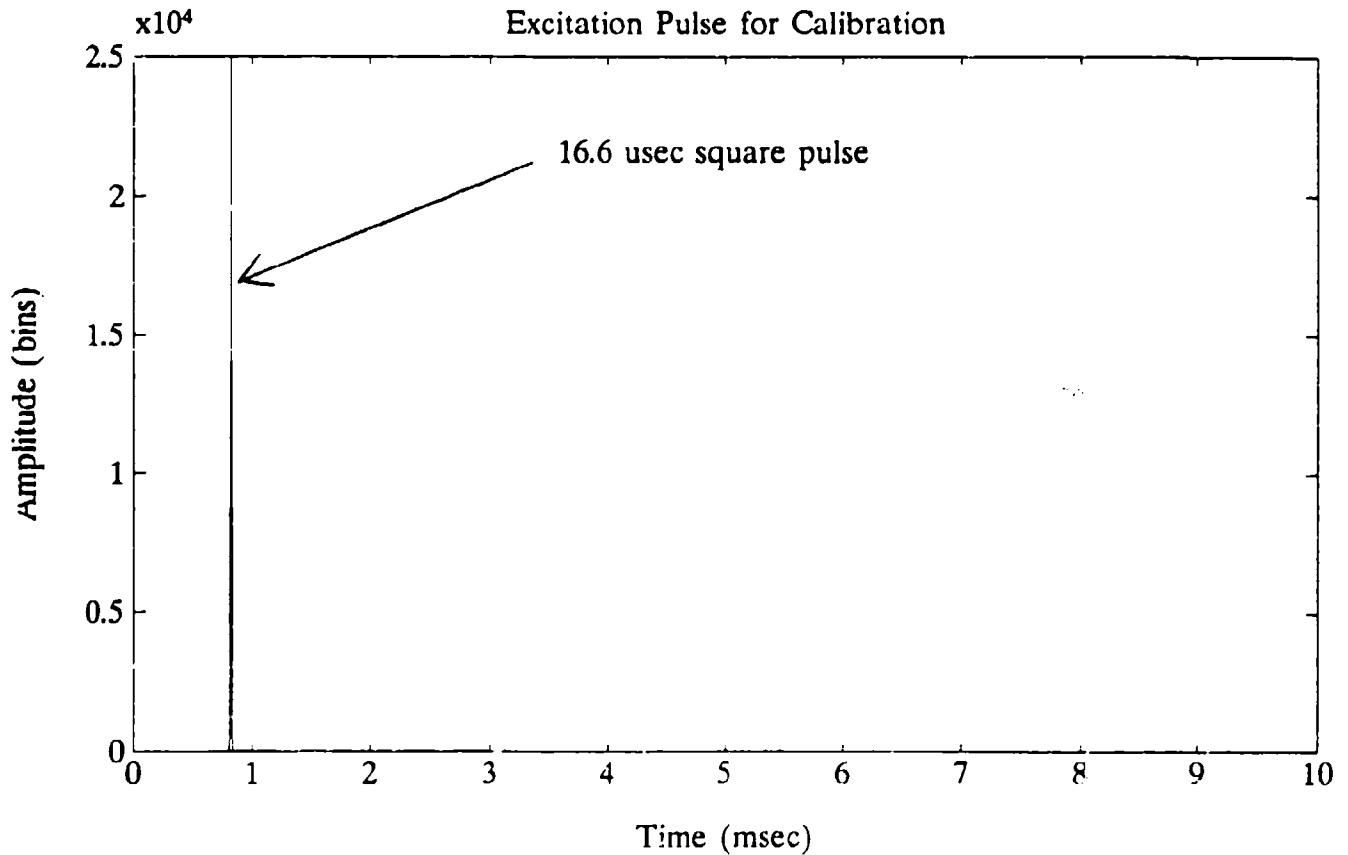
Figure 2

Excitation Pulse for Calibration

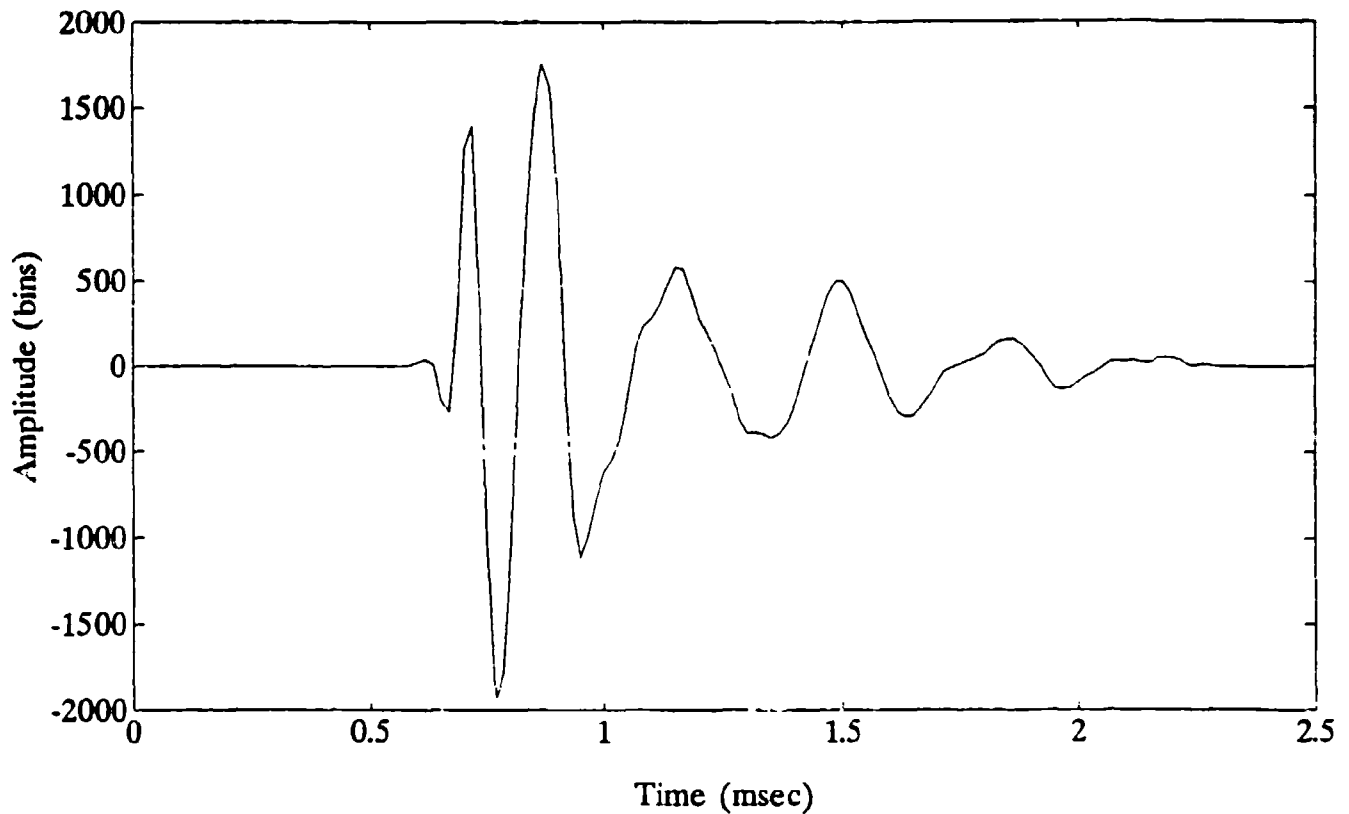
Figure 3 is a plot of the windowed impulse response and Figure 4 is the corresponding magnitude of the system transfer function. Figure 4 shows that the system can be operated between 2 kHz and 14 kHz.

Windowed Impulse Response

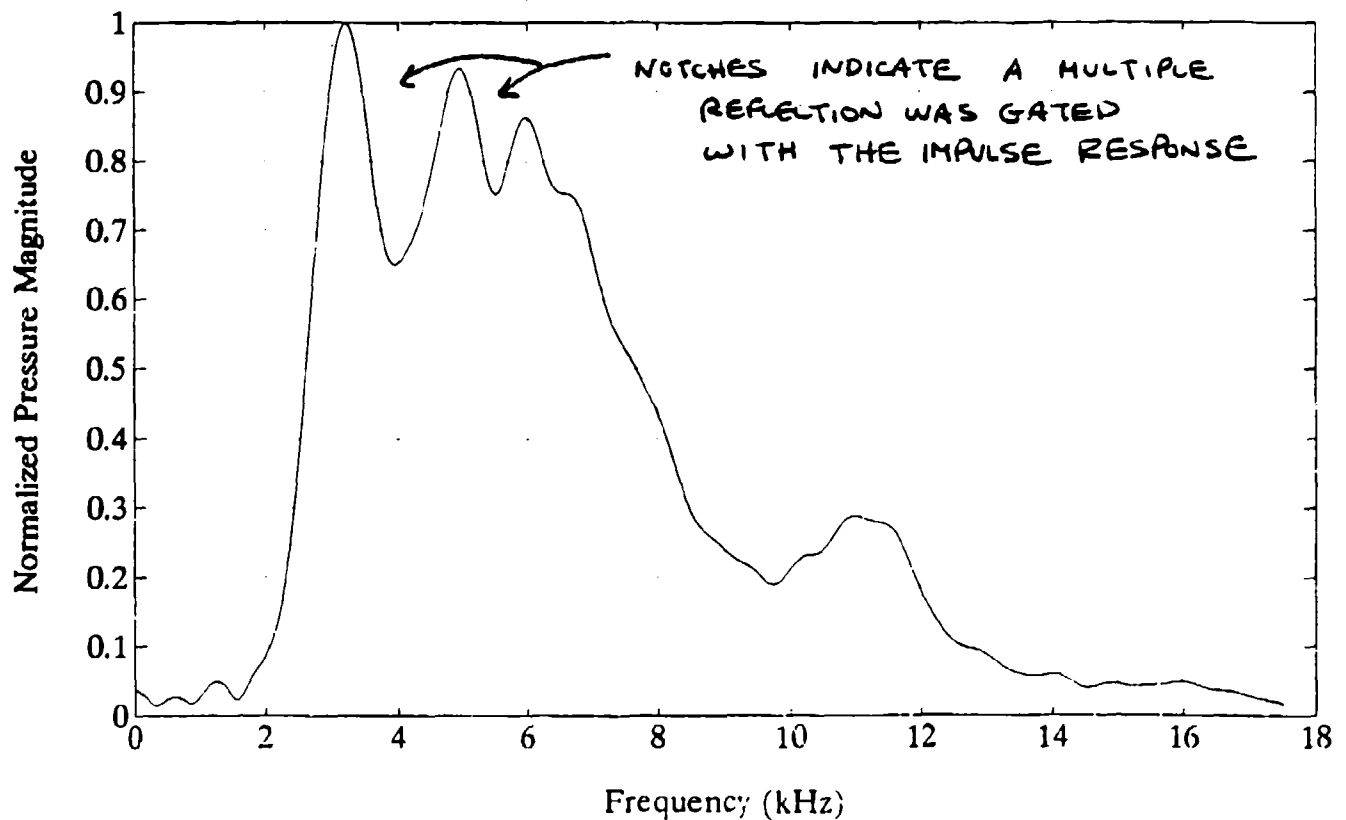
Figure 4

Frequency Response of Chirp Sonar
